Damage to part.

After all processes were finished, we were notified of a small indication of damage that was observed upon receiving inspection at the customer. This document is to outline our process in handling the part and to provide insight on possible areas in processing where the part could be damaged and how to prevent this from happening in the future.

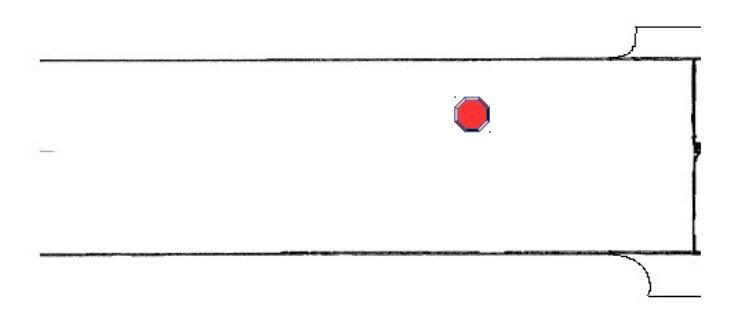
The pictures below show where the damage indication is in relation to the whole assembly (Figure A)

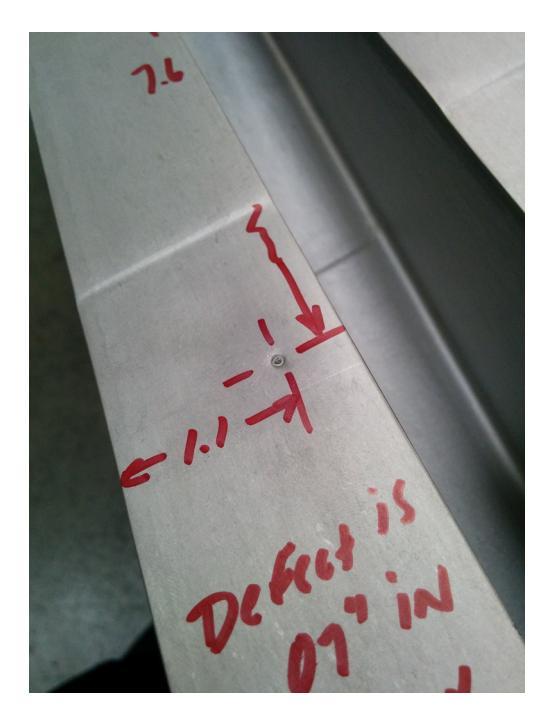
Figure B

As well as having a surface indication on the outside of the part (Figure B) damage was noted on the back side of the indication as well (Figure C)

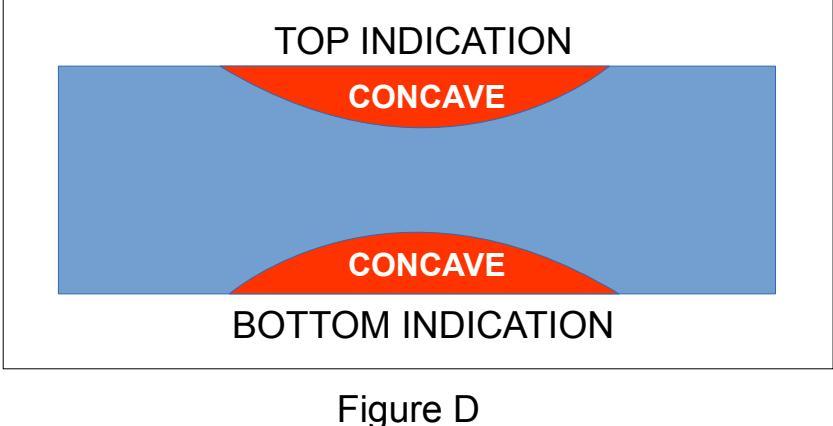
Concavity – The damage shows on both sides of the part, as if something was clamped down onto the assembly. The nature of the ding is concave on both sides, indicating that a considerable amount of force was exerted down onto the part from both ends, causing the damage. There is no process from us or the inspection house that involves clamping. See Figure D

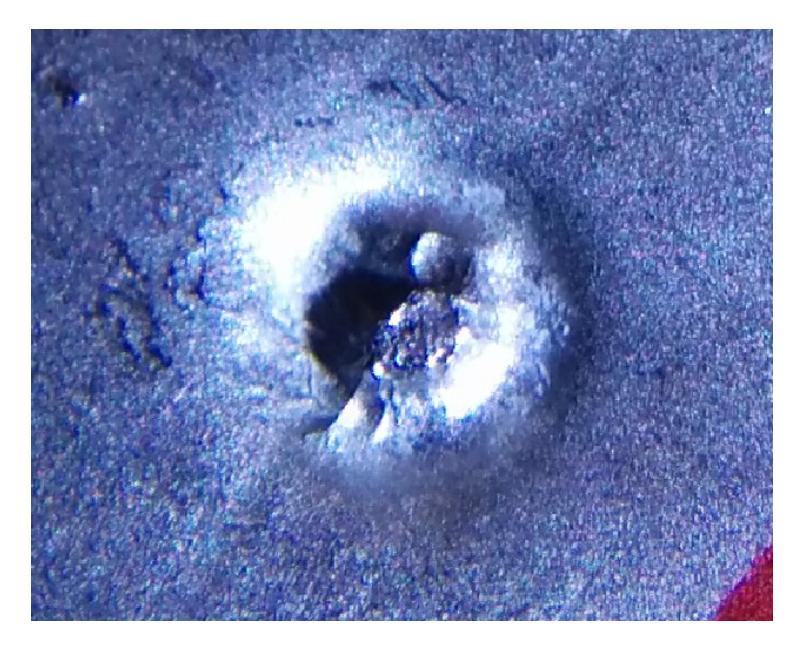
Recast – The damage appears to have happened from an electrical source, connector, or clamp of some kind. There is a recast on the top edge of the damage, which is very suspicious of heat applied to the part. There is no process from us or the inspection house that involves electrical connectors being hard attached to the part. See Figure E

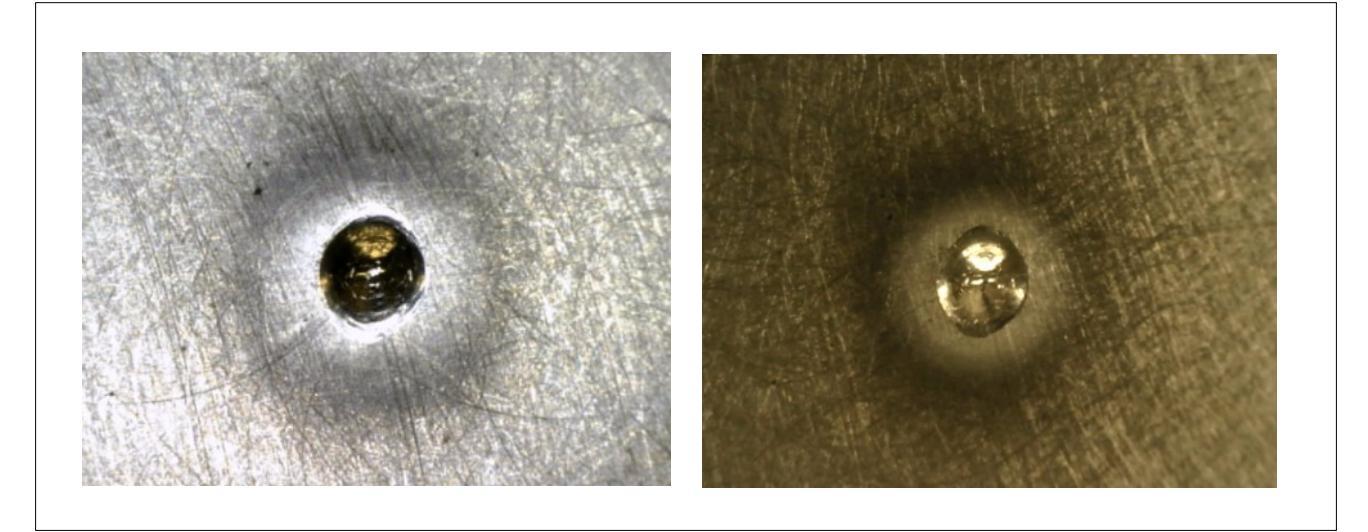
Figure G Electron Beam Strike

Electron Beam Strike – In order to show what an accidental Electron Beam Welding strike on parent material looks like, we have taken a sample part which was taken from a previous qualification for the customer. As you can clearly see, by comparison- the Weld Beam looks vastly different from the indicated damage on the part. The actual beam strike is a very clean indication, unlike the damage in question. The opposite end of the strike shows a convex nature rather than a concave indication like the damage in question. The customers weld schedule was used to fire upon the sample material, ensuring the power and other variables are exactly as they would be during the welding of a production part. See Figure G, H and next page

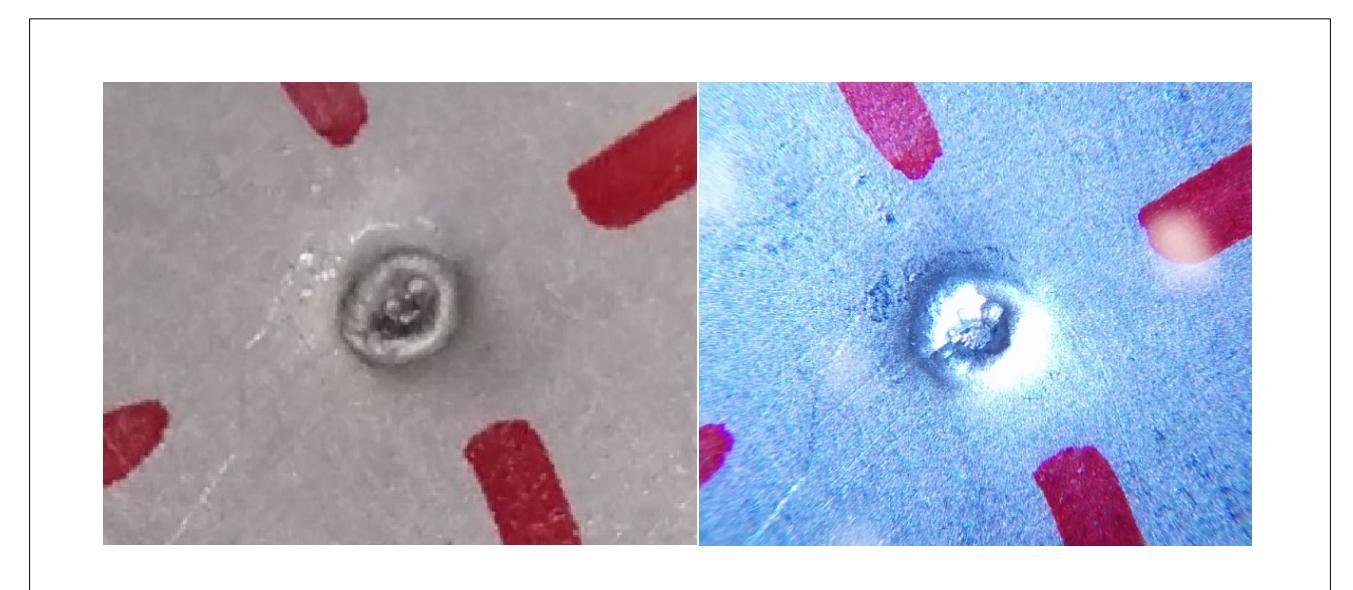
Figure H Actual Part Damage

Upon detailed observation of the damage in question, we have come to the conclusion that this damage occurred by means of a clamp that was applied down onto the part with a considerable amount of pressure. The material was dimpled on the outer and inner surface, leaving concave indications. The clamp used must have been hot, or live with electricity to cause the recast on the part. The processes at our company involve no such type of clamps or anything that could cause this damage. Upon discussion with the outside vendor, their process does not involve anything like this either.

The damage on the Spar Assembly has most definitely not been caused by an accidental beam strike, or grounding problem as the indication looks vastly different as well as being concave on both ends of the damage. There will be a considerable change in processing to scour every inch of the part during all steps of processing to ensure something like this does not slip through the processing and make it all the way back to the customer.

The damage done to the Spar Assembly is unacceptable, and there will be a change in processing both at our company and the inspection house for careful monitoring of the part.

A representative from our company will be visiting the outside vendor for close monitoring of their processing. If any process shows potential for damage happening to the part, there will be a corrective action and a full resolution to this problem.

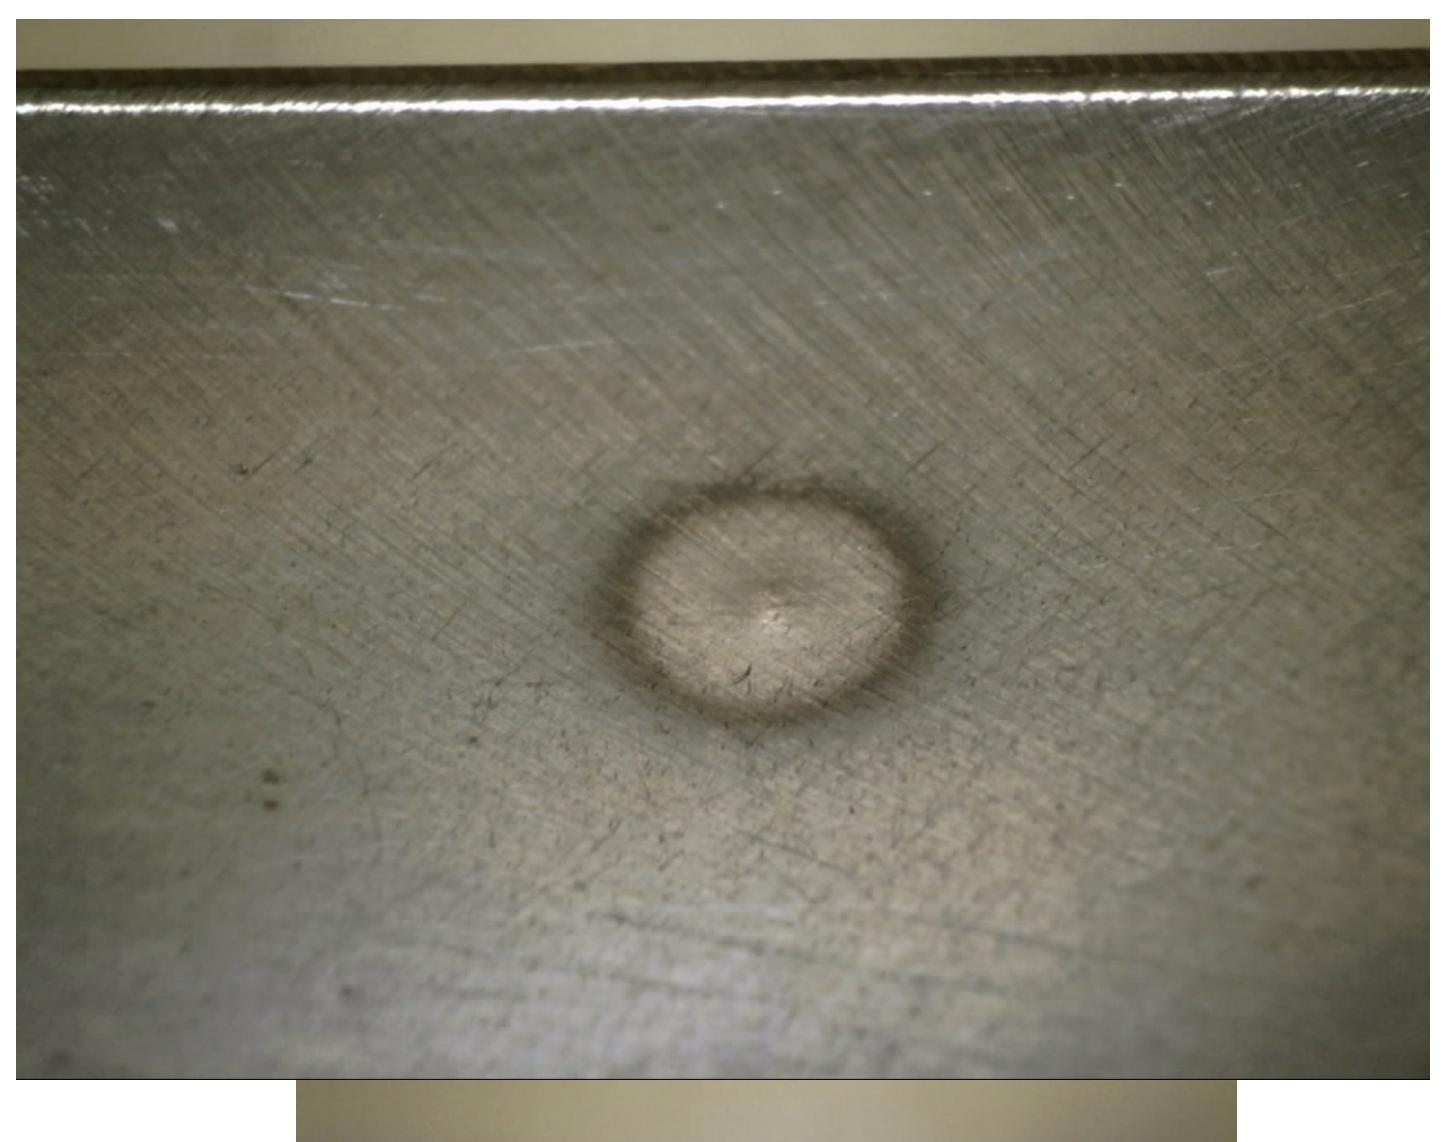
Additional Photos of Electron Beam Strike

These photos show the back side of the strike, giving visual confirmation that the opposite end of the strike is convex.
